# Manhole Inspection Summary

Manhole # S29SS\_018MH

Insp Date: **5/15/07 9:27 AM**

**Location** Address: **555 SISSON ST**

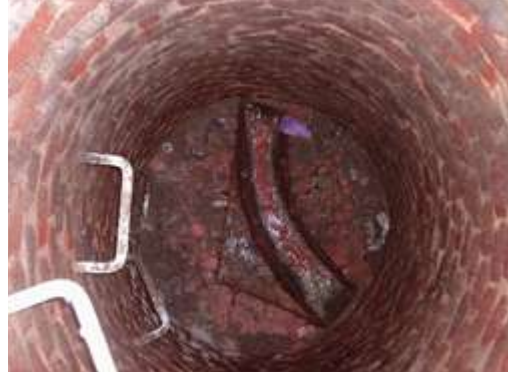
Top View

Corroded steps. Evidence of surcharge - Bench debris.

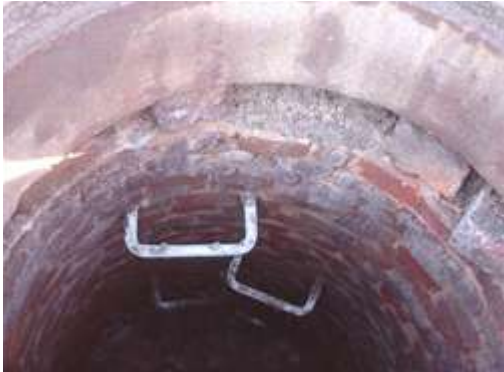
Defect

Frame leaks. Frame offset. Adjustment deterioration, loose brick and infiltration. Barrel infiltration - other side.

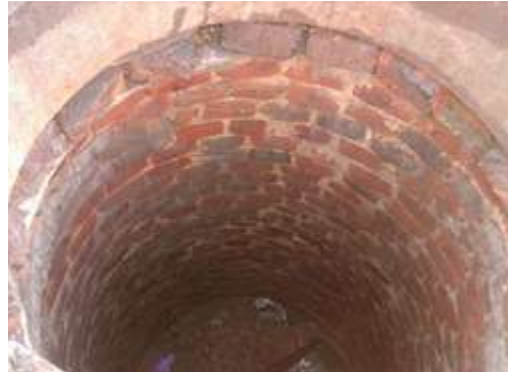
Defect

Frame leaks. Adjustment deterioration, loose brick and infiltration. Barrel infiltration.

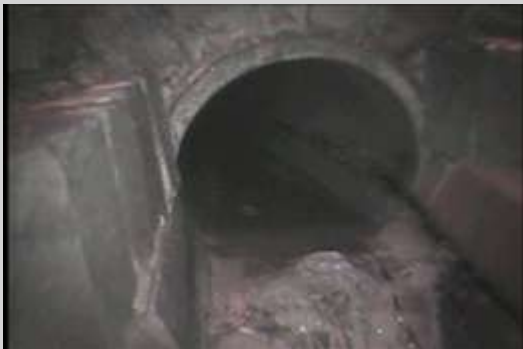
### 8 in. Circular Gravity Sewer Pipe In @ 5 O'Clock

Deposits: ☐ None ☒ **Mud** ☐ Sludge ☒ **Debris** ☐ Grease

Silt Depth: **0** (in.) Deposits Extent: **Light**

Infiltration: **Evidence** Pipe Seal Cond: **Cracked**
